BERGER ASSOCIATES INC HARRISBURG PA
NATIONAL DAM INSPECTION PROGRAM. BEAVER LAKE DAM (NDI-ID NUMBER--ETC(U)
AUG 80 H JONGSMA

PHASE I REPORT
NATIONAL DAM INSPECTION PROGRAM

Name of Dam: BEAVER LAKE DAM
State & State No.: PENNSYLVANIA, 64-180
County: WAYNE
Stream: TRIBUTARY TO DYBERRY CREEK
Date of Inspection: May 7, 1980

NDI-ID PA-00160,
DER-ID 64-180

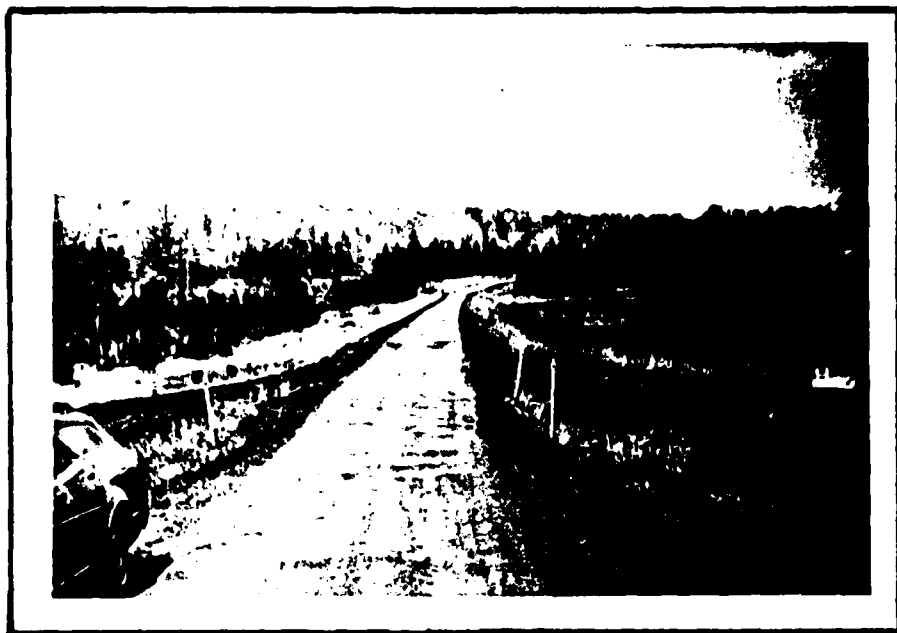
OVERVIEW FROM LEFT ABUTMENT - NO. 2
